RST Rail System Testing GmbH
Walter-Kleinow-Ring 7
16761 Hennigsdorf (Germany)Fon +49 (0)3302 49982 0
Fax +49 (0)3302 49982 15www.rst-labs.de
info@rst-labs.de**Test Report No. P50-18-0403_1-en****Environmental Tests**Order No.: 50-18-0403
Date: 20/12/2018
Editor: Mr. Koch
Documentation: krThis report includes
27 pages.

- 1 Ultrasonic wind sensor
- 1 ARCO-SERIAL combined wind sensor NMEA
- 1 PRO-WEA WG-SENSOR 4-20 mA, 0-60 m/s
- 1 PRO-WEA WR-SENSOR 4-20 mA,
- 1 PROFESSIONAL Sensor ice free IX 3.0 WR
- 1 PROFESSIONAL Sensor ice free IX 2.0 WG
- 1 INDUSRTY wind direction sensor
- 1 THP-NAV temp.-humid.-pressure-sensor in a sensor-protection housing

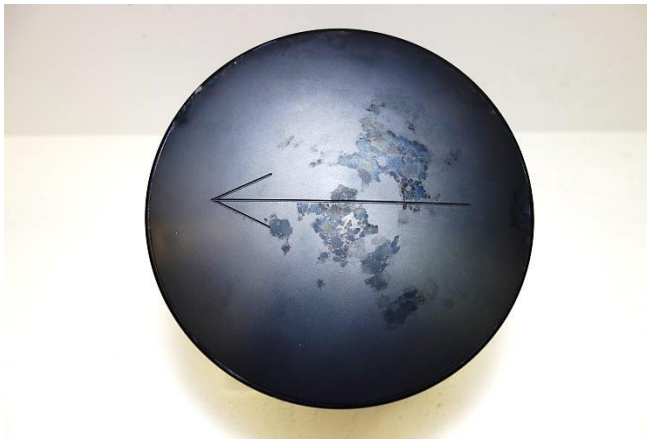
fig. 13

Specimen no. 50-18-0403-1
after the condensation test

Stains on the surface and surface defects
at the black anodized layer

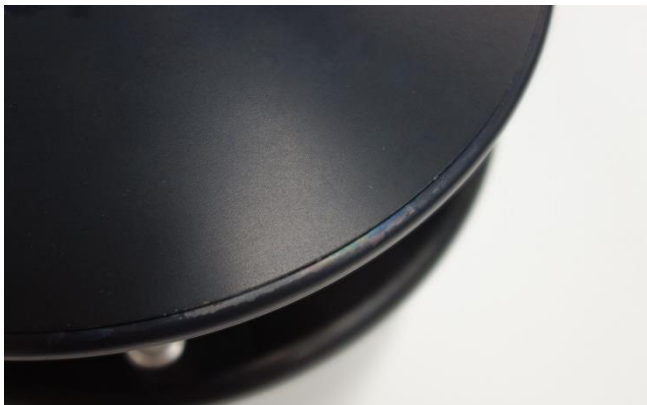
fig. 14

Specimen no. 50-18-0403-1
after the condensation test

Stains on the surface and surface defects
at the black anodized layer

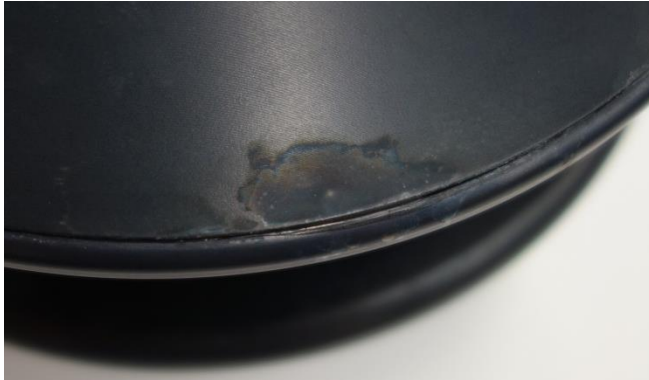
fig. 15

Specimen no. 50-18-0403-1
after the condensation test

Stains on the surface and surface defects
at the black anodized layer

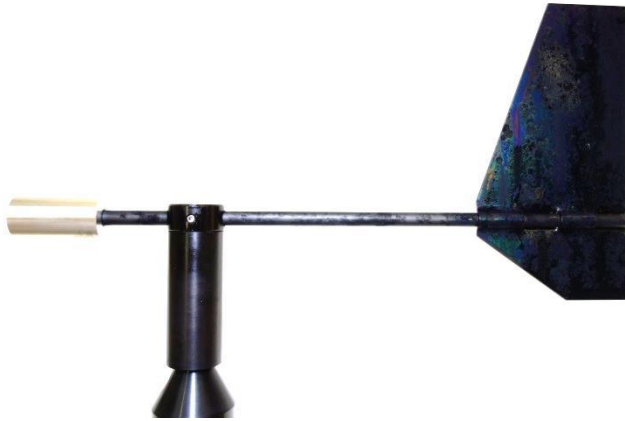
fig. 17

Specimen no. 50-18-0403-2
after the condensation test

Surface defects at the black anodized
layer (wind direction vane, crossbar and
holder cup)

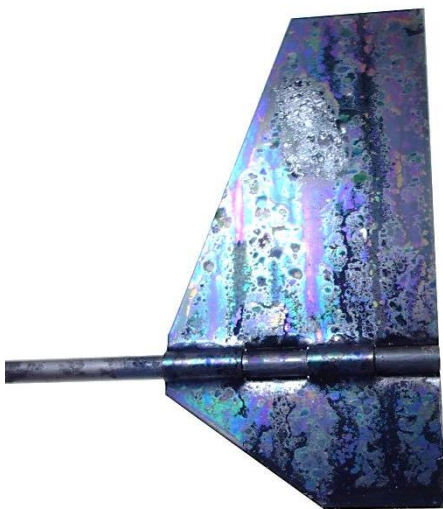
fig. 18

Specimen no. 50-18-0403-2
after the condensation test

Detailed: wind direction vane;
surface defects at the black anodized
layer

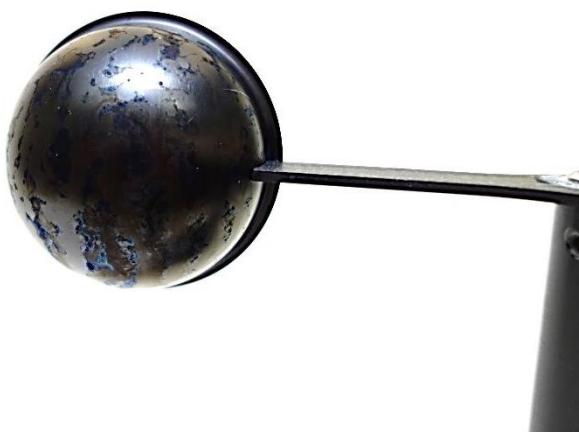
fig. 19

Specimen no. 50-18-0403-2
after the condensation test

Surface defects at the black anodized
layer (rotor cups)

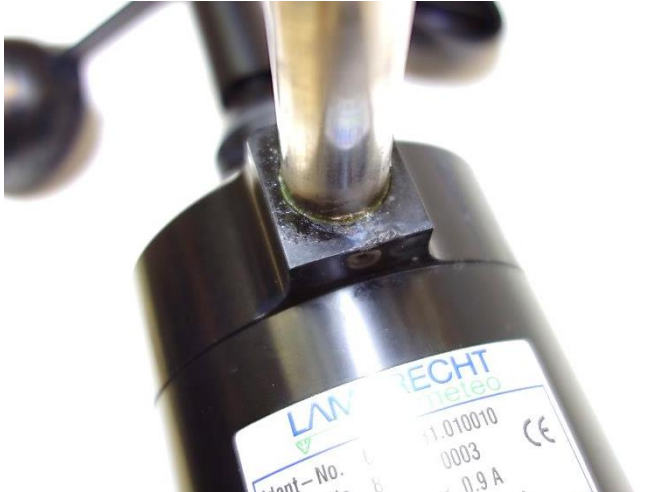
fig. 20

Specimen no. 50-18-0403-2
after the condensation test

Verdigris between housing and bow
connection

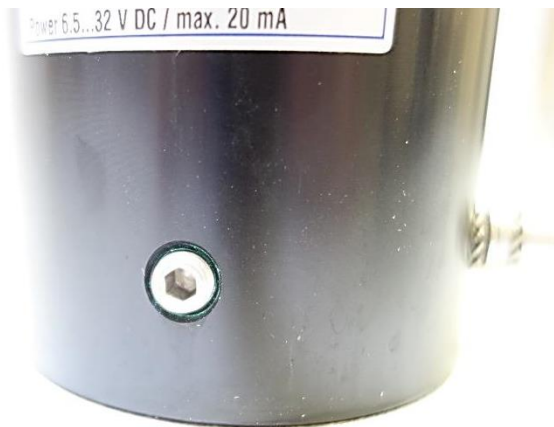
fig. 21

Specimen no. 50-18-0403-2
after the condensation test

Verdigris between housing and a screw

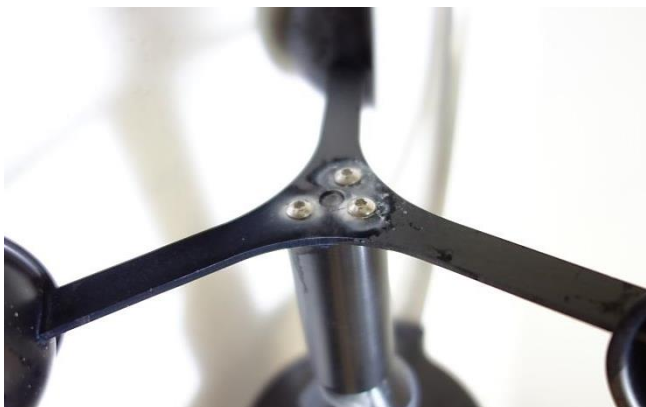
fig. 22

Specimen no. 50-18-0403-2
after the condensation test

White corrosion products around the cup
rotor screws

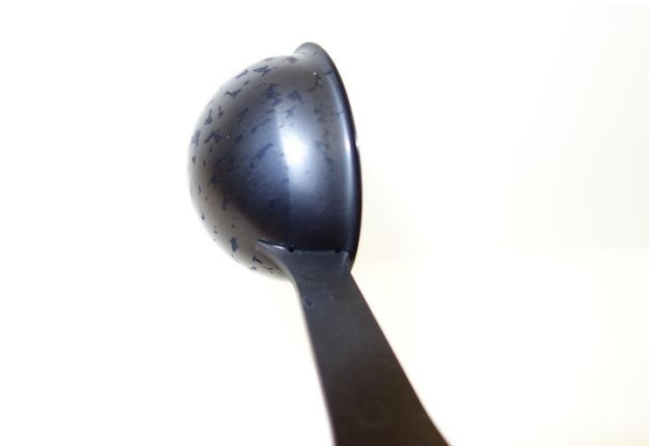
fig. 24

Specimen no. 50-18-0403-3
after the condensation test

Stains on the surface and surface defects
at the black anodized layer (rotor cups)

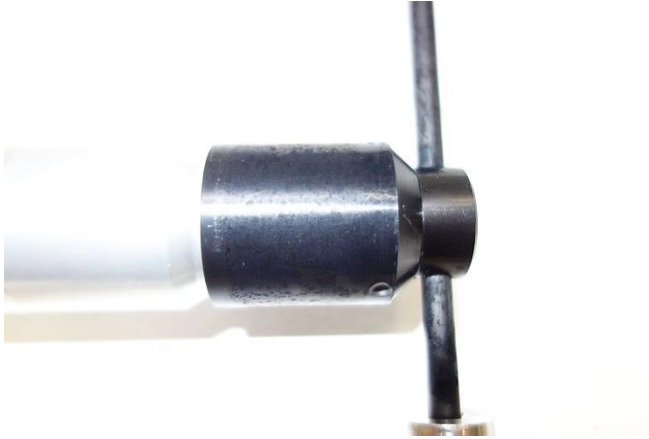
fig. 26

Specimen no. 50-18-0403-4
after the condensation test

Stains on the surfaces and corrosion
phenomena (aluminum)

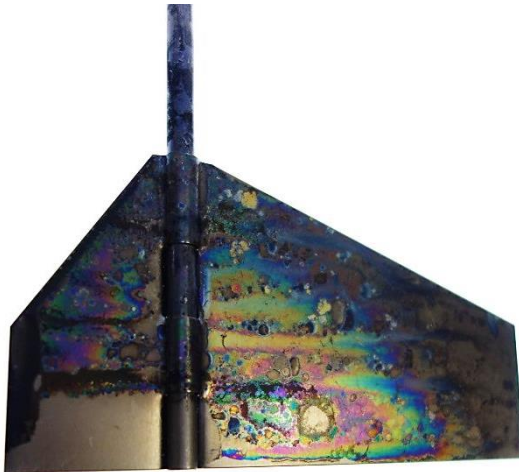
fig. 27

Specimen no. 50-18-0403-4
after the condensation test

Stains on the surface and surface defects
at the black anodized layer

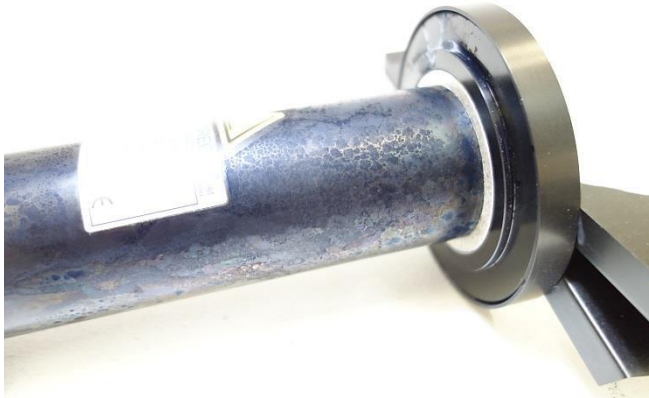
fig. 29

Specimen no. 50-18-0403-5
after the condensation test

Stains on the surface and surface defects
at the black anodized layer

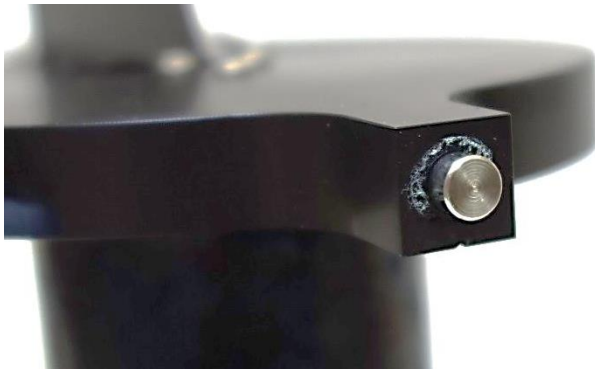
fig. 30

Specimen no. 50-18-0403-5
after the condensation test

White corrosion products around the
screw

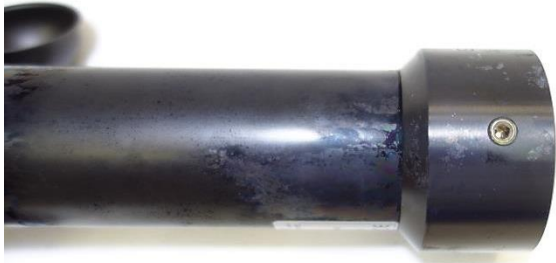
fig. 32

Specimen no. 50-18-0403-6
after the condensation test

Stains on the surface

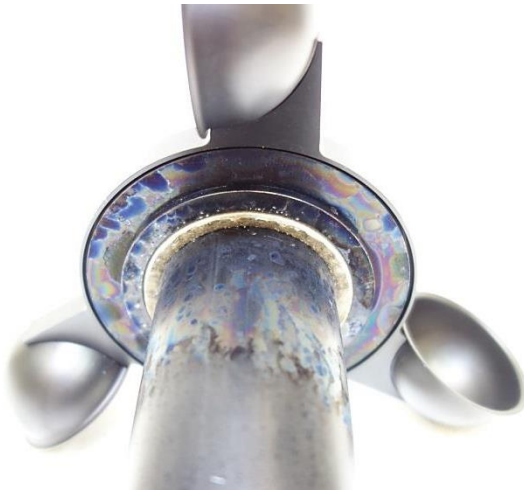
fig. 33

Specimen no. 50-18-0403-6
after the condensation test

Stains on the surface and surface defects
in the black anodized layer

Swollen seal between housing and cup
rotor

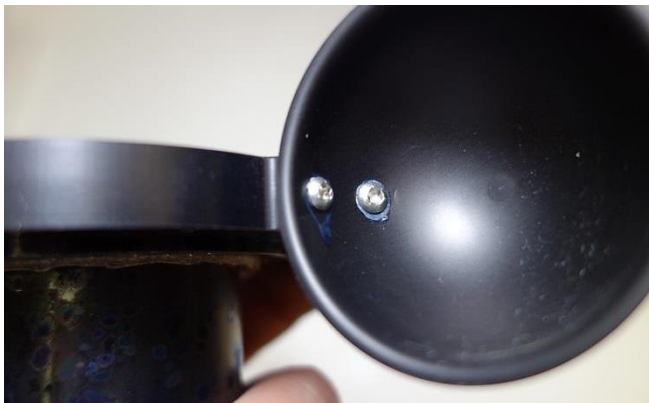
fig. 34

Specimen no. 50-18-0403-6
after the condensation test

White corrosion products around the cup
screws

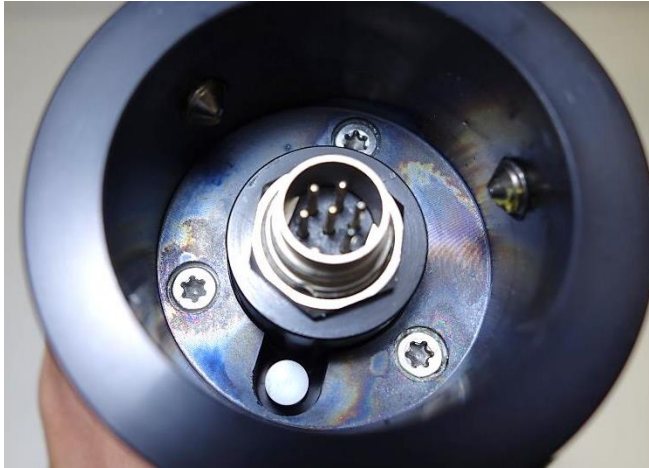
fig. 35

Specimen no. 50-18-0403-6
after the condensation test

Stains on the surface and surface defects
at the black anodized layer (bottom)

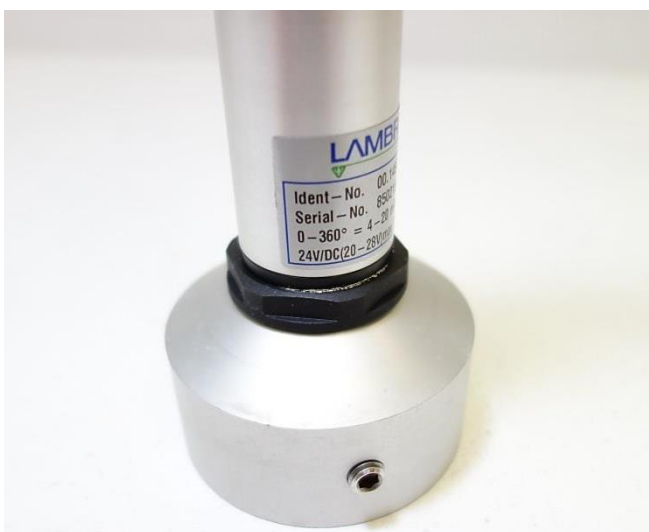
fig. 37

Specimen no. 50-18-0403-7
after the condensation test

White deposits at the nut

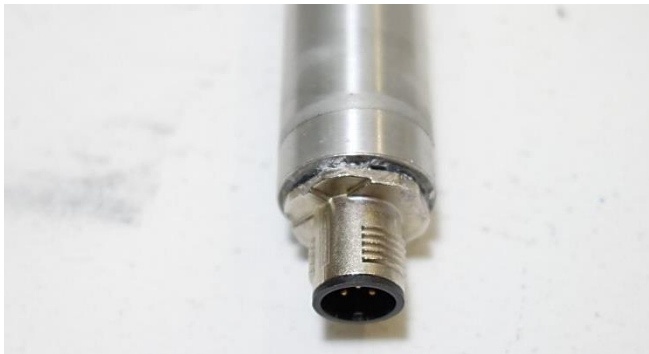
fig. 39

Specimen no. 50-18-0403-8a
after the condensation test

White corrosion products around the
connector

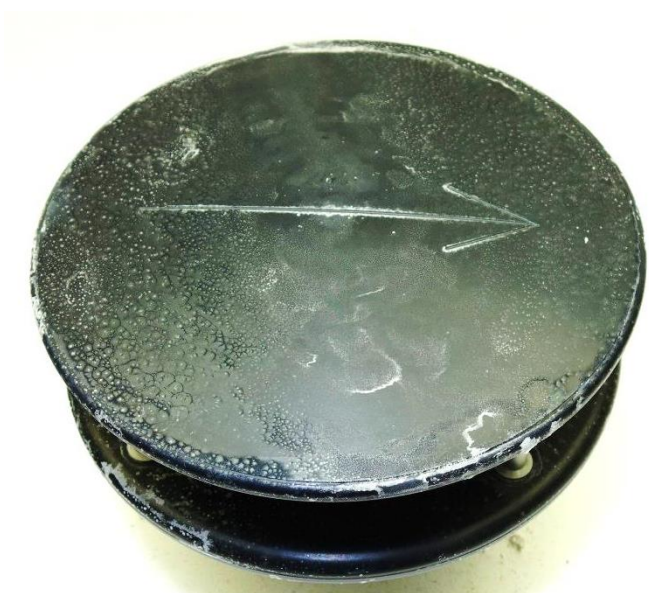
fig. 43

Specimen no. 50-18-0403-1
after the salt mist test

Stains on the surfaces and surface
defects at the black anodized layer

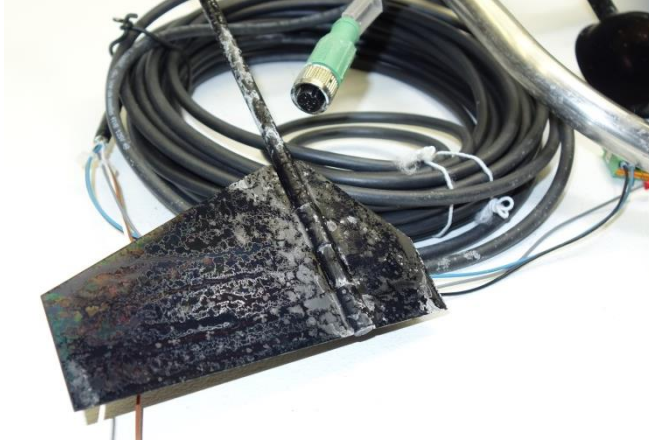
fig. 45

Specimen no. 50-18-0403-2
after the salt mist test

Stains on the surfaces and surface
defects at the black anodized layer

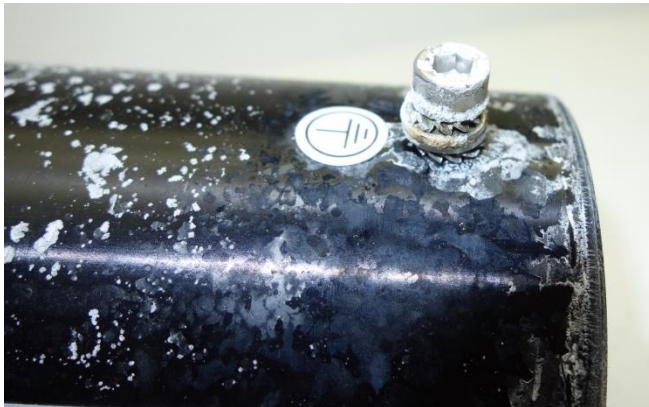
fig. 46

Specimen no. 50-18-0403-2
after the salt mist test

Stains on the surfaces and surface
defects at the black anodized layer

Corrosion at the screw

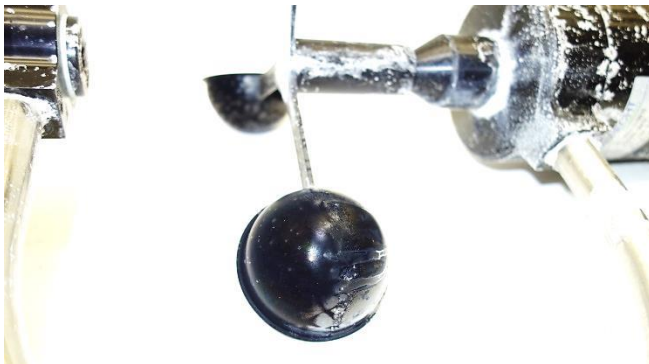
fig. 47

Specimen no. 50-18-0403-2
after the salt mist test

Stains on the surfaces and surface
defects at the black anodized layer (rotor
cup)

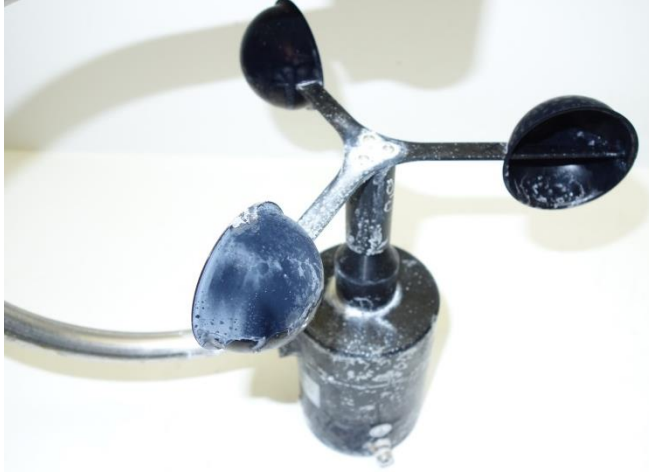
fig. 48

Specimen no. 50-18-0403-2
after the salt mist test

Stains on the surfaces and surface
defects at the black anodized layer

White deposits on the cup rotor and cup

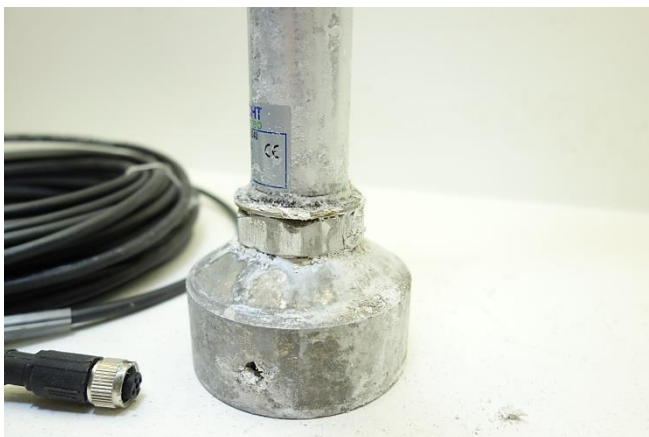
fig. 50

Specimen no. 50-18-0403-3
after the salt mist test

Aluminium corrosion of the housing

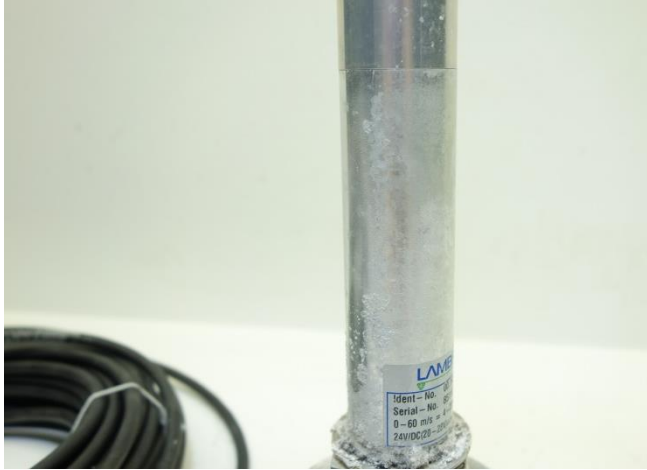
fig. 51

Specimen no. 50-18-0403-3
after the salt mist test

Aluminium corrosion of the housing

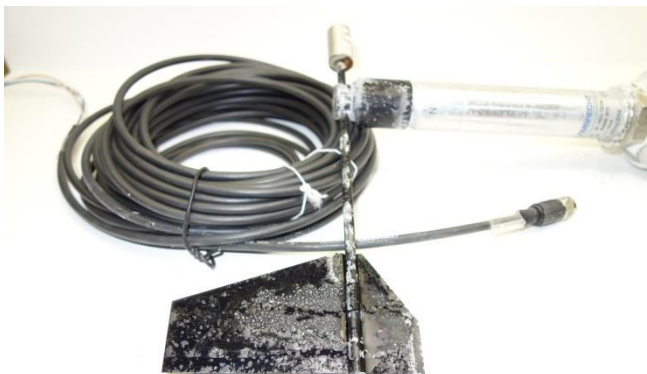
fig. 53

Specimen no. 50-18-0403-4
after the salt mist test

Stains on the surfaces and surface
defects at the black anodized layer

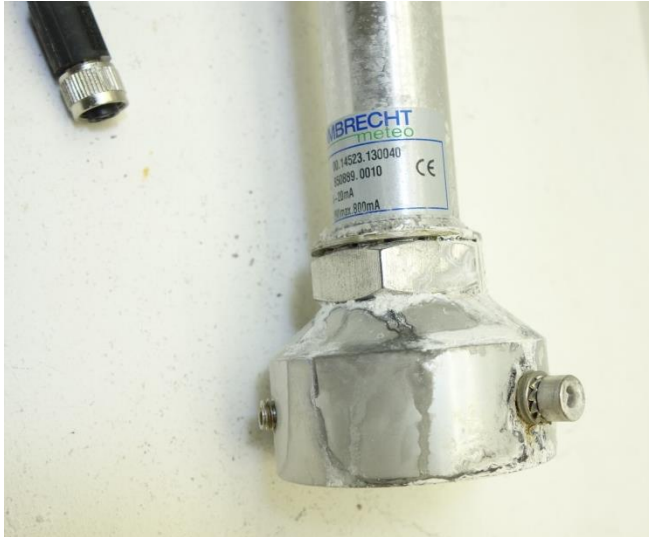
fig. 54

Specimen no. 50-18-0403-4
after the salt mist test

Signs of corrosion of the housing
White and grey deposits between nut and
sensor housing (no evaluation of the foot)

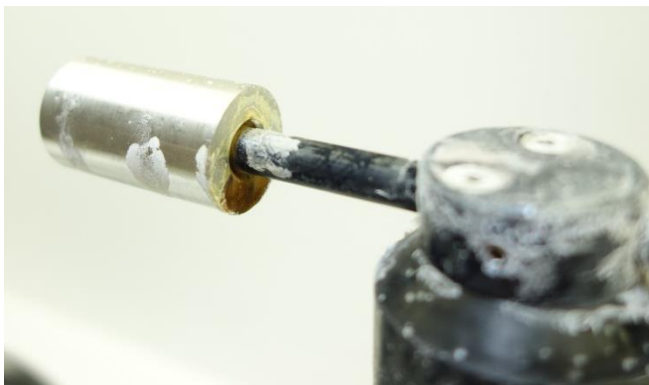
fig. 55

Specimen no. 50-18-0403-4
after the salt mist test

Corrosion products (red rust and white
deposits between the front mass and
cross beam)

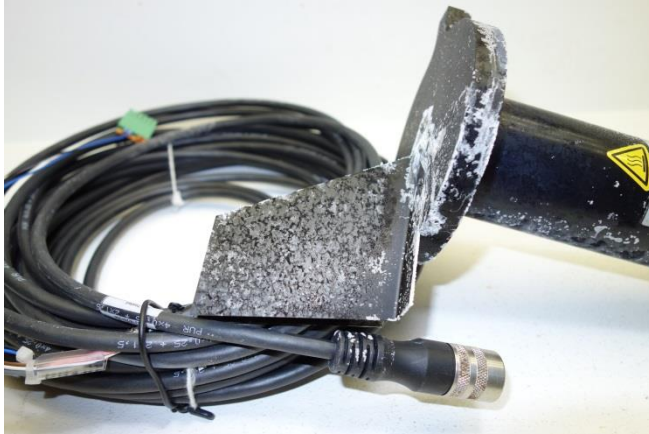
fig. 57

Specimen no. 50-18-0403-5
after the salt mist test

Stains on the surfaces and surface
defects at the black anodized layer

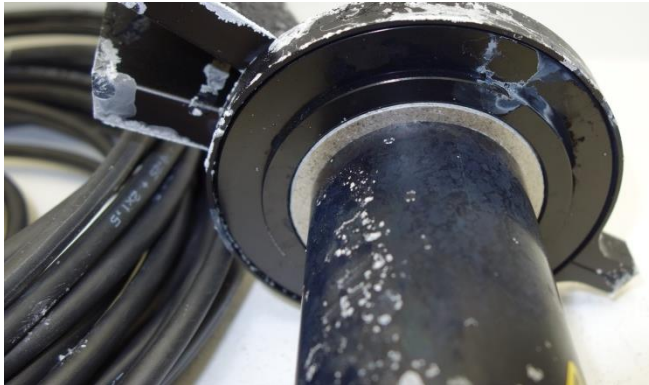
fig. 58

Specimen no. 50-18-0403-5
after the salt mist test

Stains on the surfaces and surface
defects at the black anodized layer

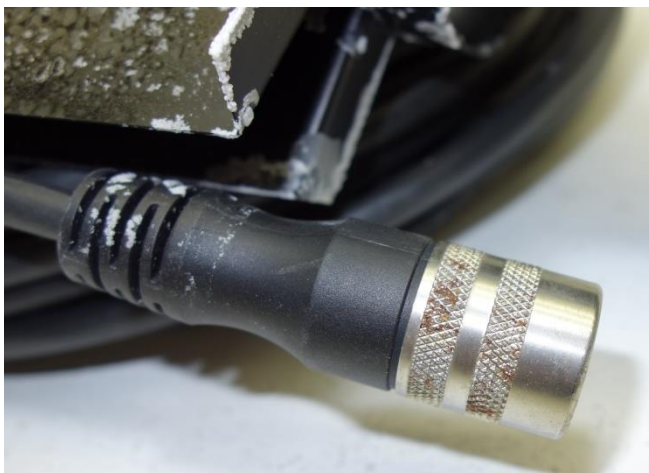
fig. 59

Specimen no. 50-18-0403-5
after the salt mist test

Red rust at the connector housing

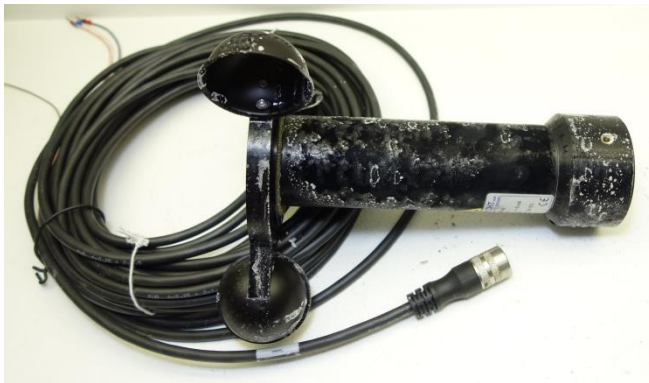
fig. 61

Specimen no. 50-18-0403-6
after the salt mist test

Stains on the surfaces and surface
defects at the black anodized layer

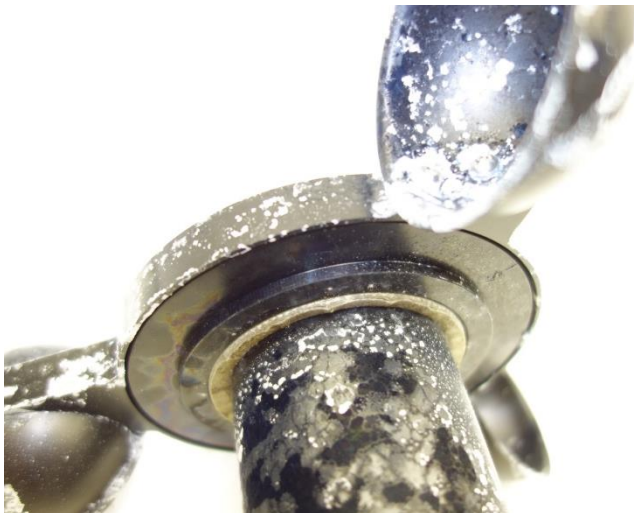
fig. 62

Specimen no. 50-18-0403-6
after the salt mist test

Stains on the surfaces and surface
defects at the black anodized layer

Defect seal

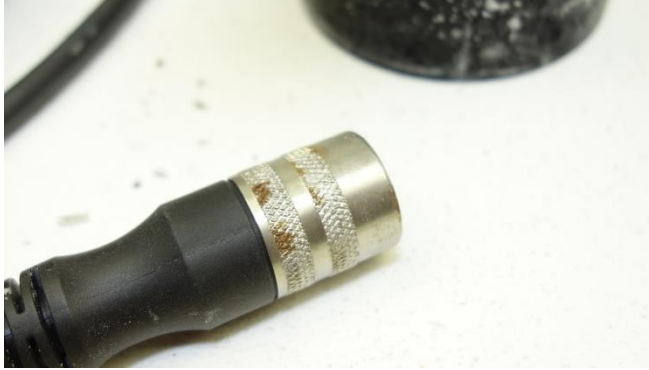
fig. 63

Specimen no. 50-18-0403-6
after the salt mist test

Red rust at the connector housing

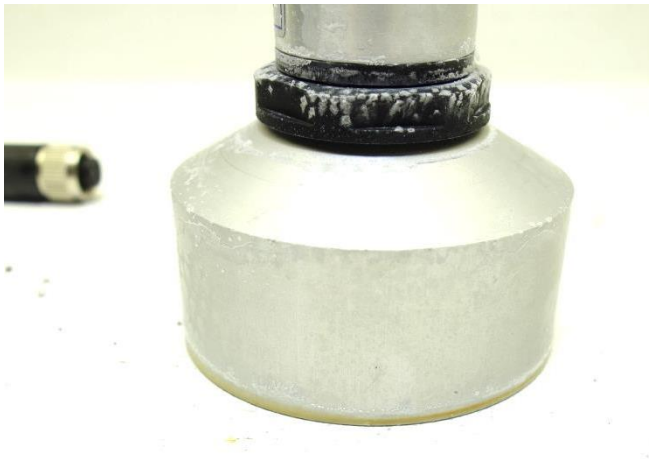
fig. 65

Specimen no. 50-18-0403-7
after the salt mist test

White deposits at the nut
(no evaluation of the foot)

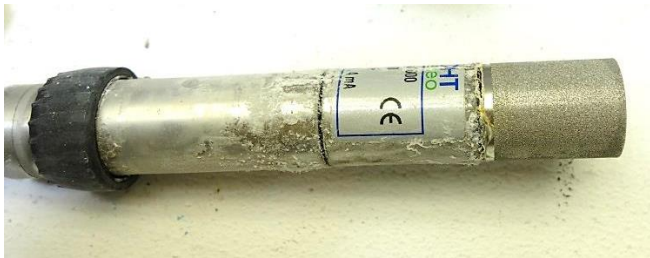
fig. 68

Specimen no. 50-18-0403-8a
after the salt mist test

White deposits and corrosion traces at the
sensor

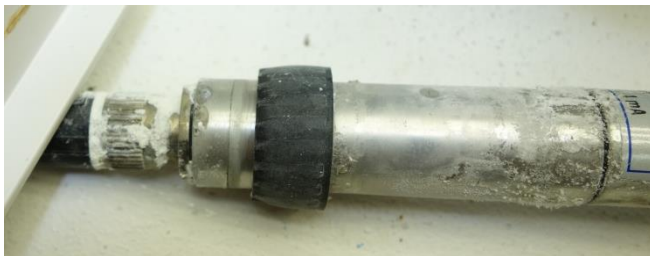
fig. 69

Specimen no. 50-18-0403-8a removed
from Specimen no. 50-18-0403-8b
after the salt mist test

White deposits at the surface
plug not removable (normal force)

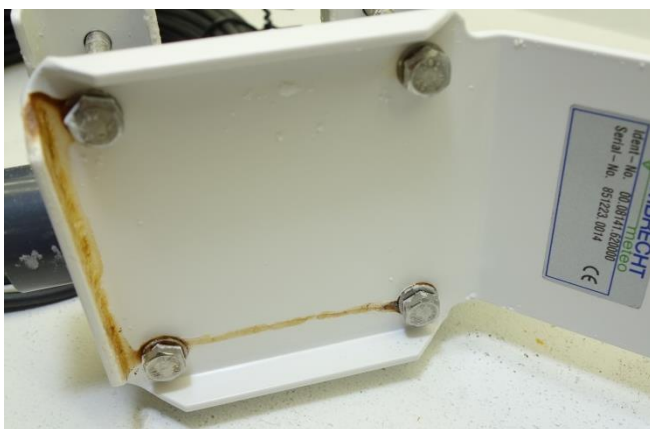
fig. 70

Specimen no. 50-18-0403-8b
after the salt mist test

Red rust under the connection screws
(coating defects)

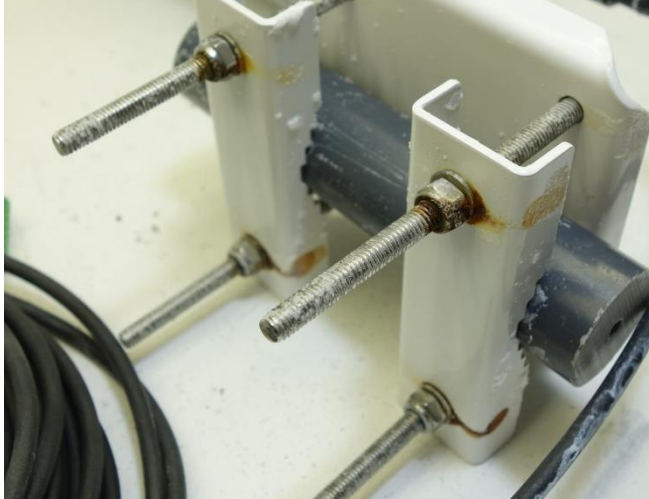
fig. 71

Specimen no. 50-18-0403-8b
after the salt mist test

Red rust under the connection
screws/nuts (coating defects)
