Environmental Simulation Laboratory
DAkKS accredited according DIN EN ISO/IEC 17025:2005

Test Report No.: SSI 6-16

Device Under Test: Ombrometer rain[e]H3
(DUT)

Test description: Solar simulation

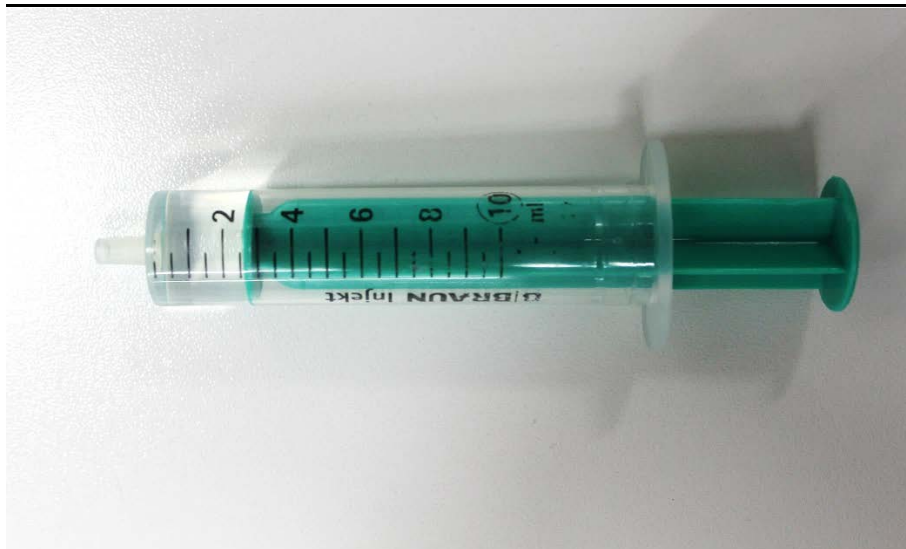
Figure 3: Syringe with 2.5 ml of water

Der Niederschlagssensor wurde unmittelbar vor dem Beginn der Prüfung mit einer Wassermenge von ca. 2,5 ml gefüllt. Die Messdaten werden alle 10 Sekunden vom Sensor ausgegeben und im Prüfsystem gespeichert. Die in Folge angezeigte Niederschlagsgesamtmenge beträgt konstant 0.137 mm/m².

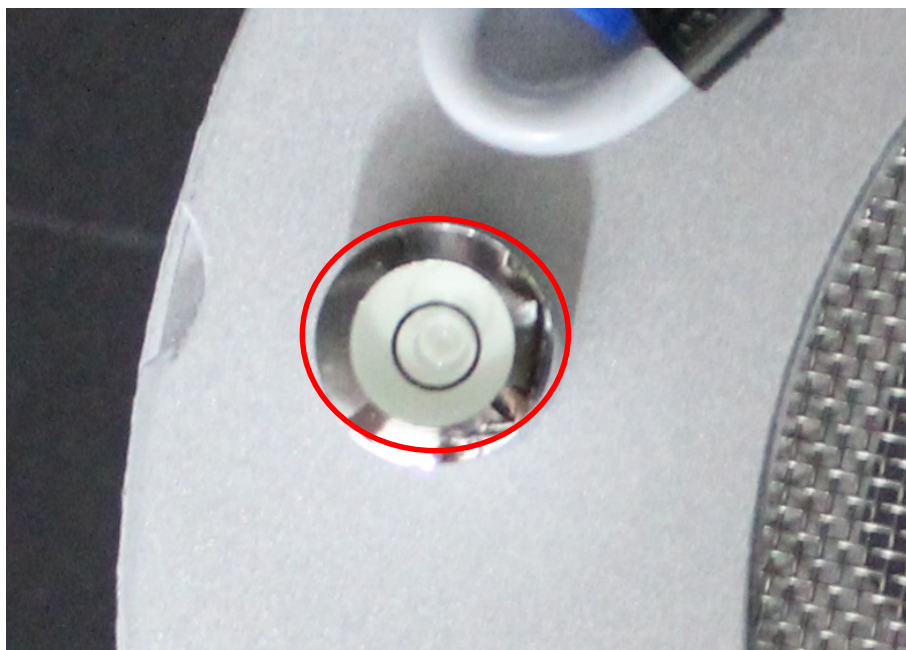
Figure 6: Leveling of set up during installation (close-up view)

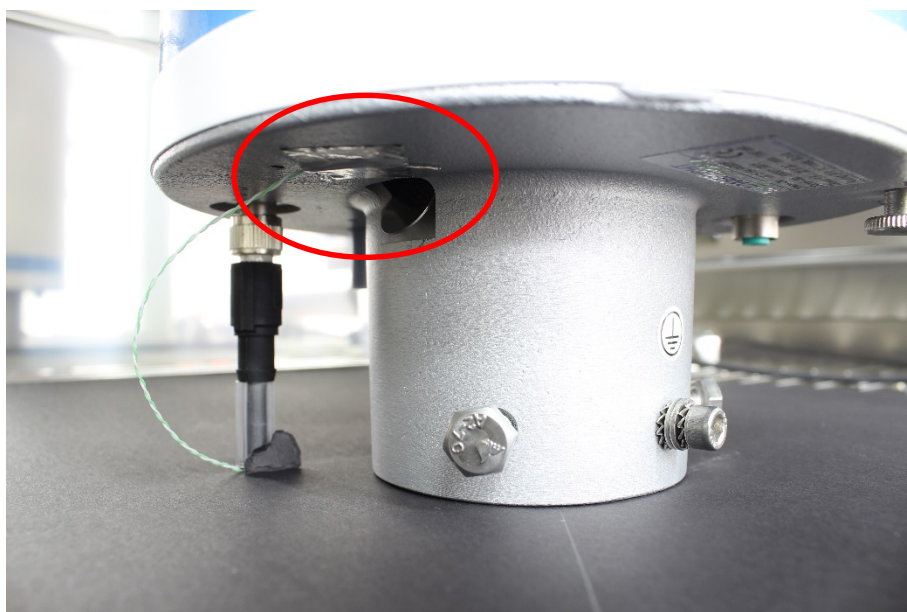
Figure 8: Point of temperature measurement (base)

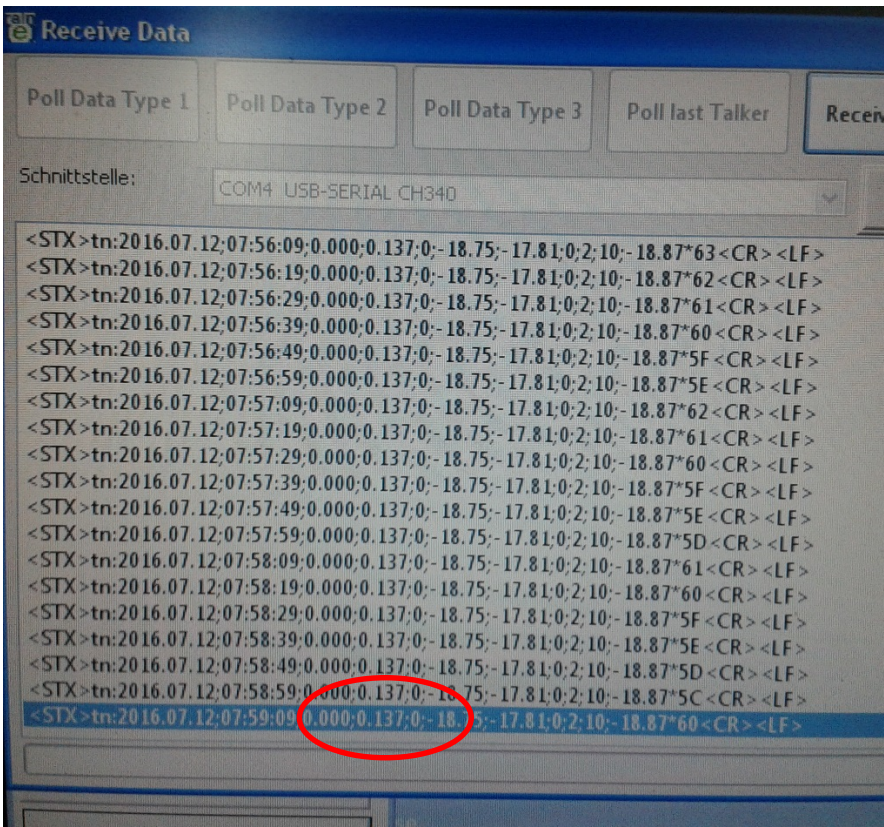
Figure 14: Sensor measurement after test run 3

Prüfdurchführung erfolgte in 8 Schritten. Während jedem Schritt erfolgte die Sonneneinstrahlung unter einem Winkelbereich von 45°. Eine Veränderung der kontinuierlich aufgezeichneten Messwerte durch Sonnenstrahlung aus den unterschiedlichen Richtungen 1-8 wurde nicht nachgewiesen. Über den gesamten Prüfzeitraum blieb die Anzeige der Niederschlagsgesamtmenge mit 0,137 mm/m² unverändert.

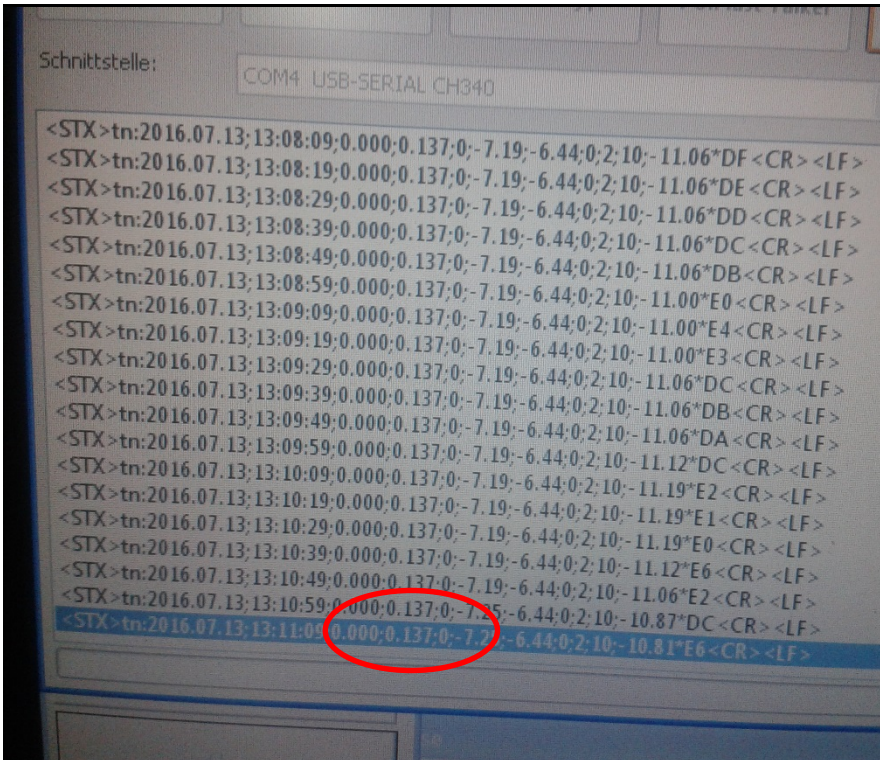
Figure 17: Sensor measurement after test run 6

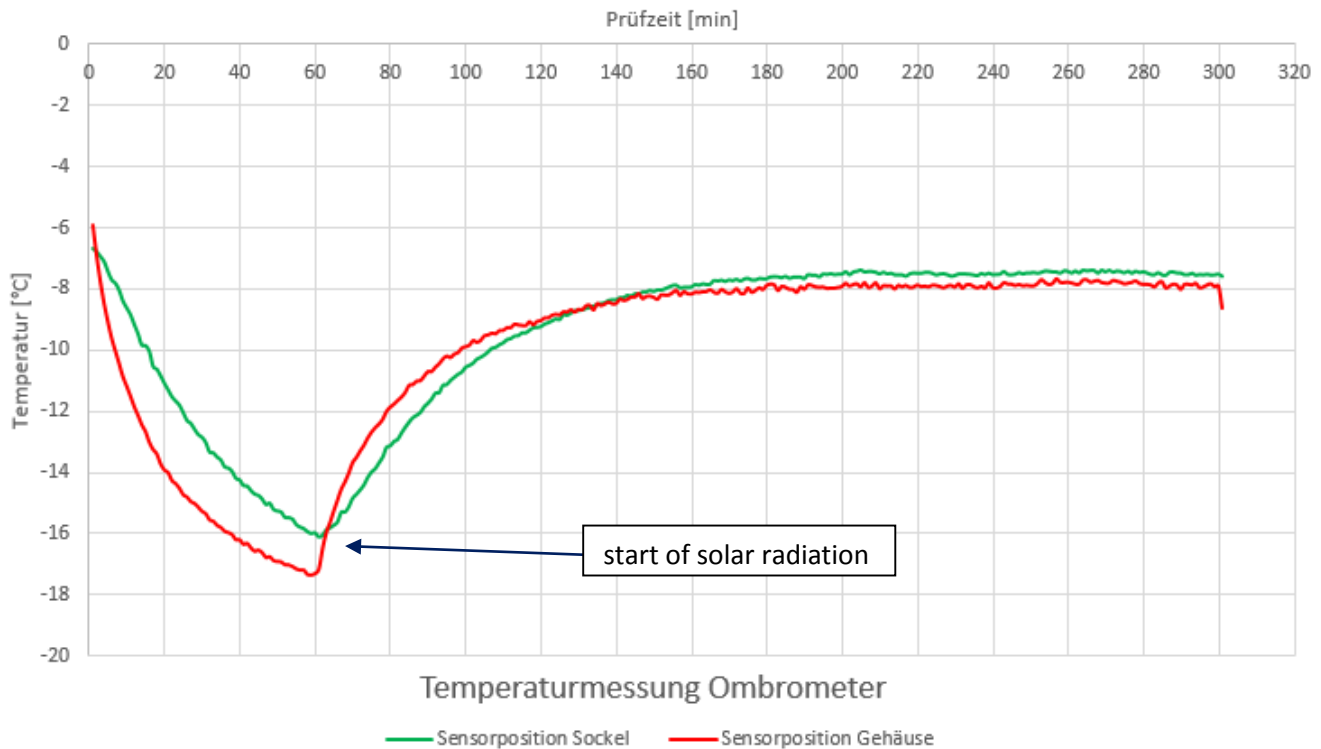
Figure 20: Temperature measurement (casing and base) during testing (exemplary)
