RST Rail System Testing GmbH
Walter-Kleinow-Ring 7
16761 Hennigsdorf (Germany)Fon +49 (0)3302 49982 0
Fax +49 (0)3302 49982 15www.rst-labs.de
info@rst-labs.de**Test Report No. P50-18-0403_1-en****Environmental Tests**Order No.: 50-18-0403
Date: 20/12/2018
Editor: Mr. Koch
Documentation: krThis report includes
27 pages.

- 1 Ultrasonic wind sensor
- 1 ARCO-SERIAL combined wind sensor NMEA
- 1 PRO-WEA WG-SENSOR 4-20 mA, 0-60 m/s
- 1 PRO-WEA WR-SENSOR 4-20 mA,
- 1 PROFESSIONAL Sensor ice free IX 3.0 WR
- 1 PROFESSIONAL Sensor ice free IX 2.0 WG
- 1 INDUSRTY wind direction sensor
- 1 THP-NAV temp.-humid.-pressure-sensor in a sensor-protection housing

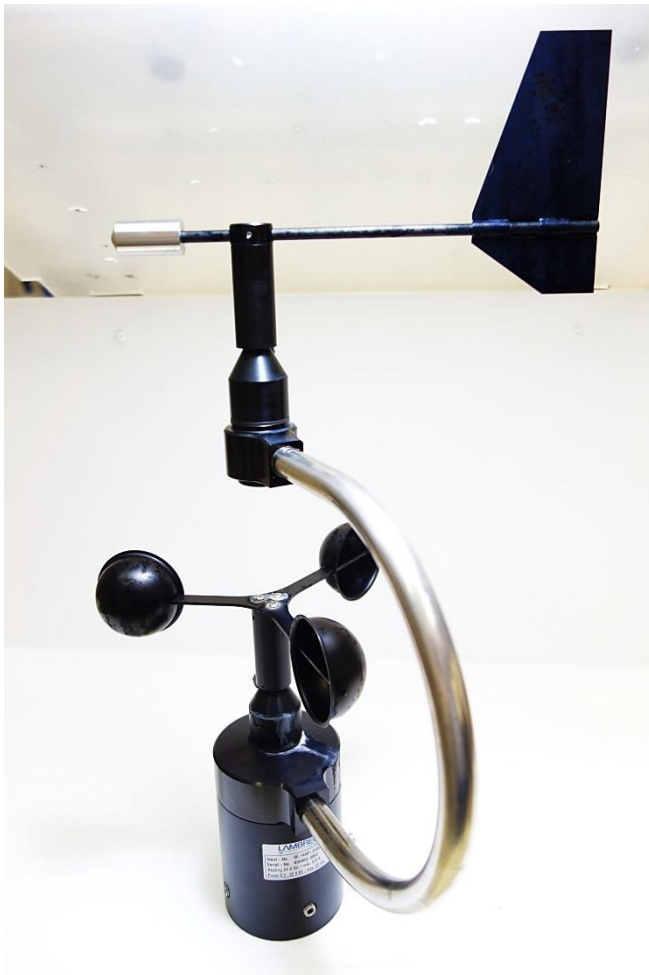
fig. 16

Specimen no. 50-18-0403-2
after the condensation test

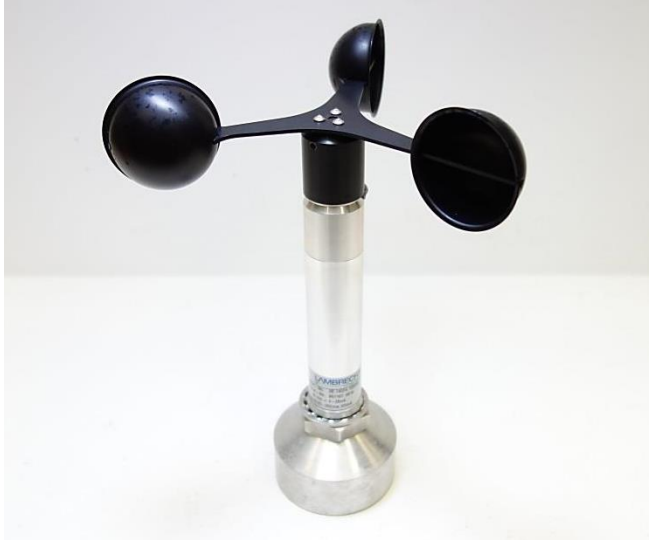
fig. 23

Specimen no. 50-18-0403-3
after the condensation test

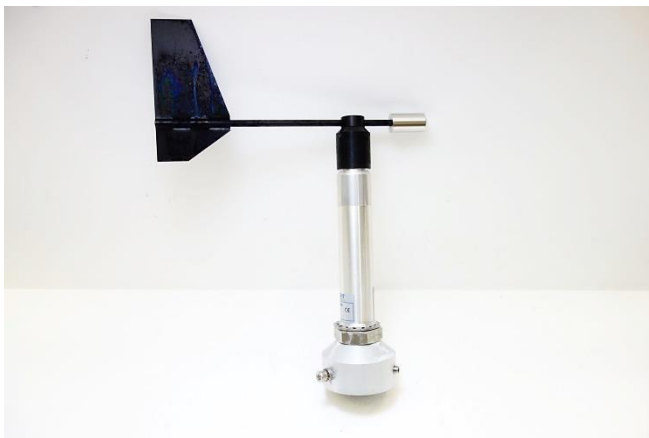
fig. 25

Specimen no. 50-18-0403-4
after the condensation test

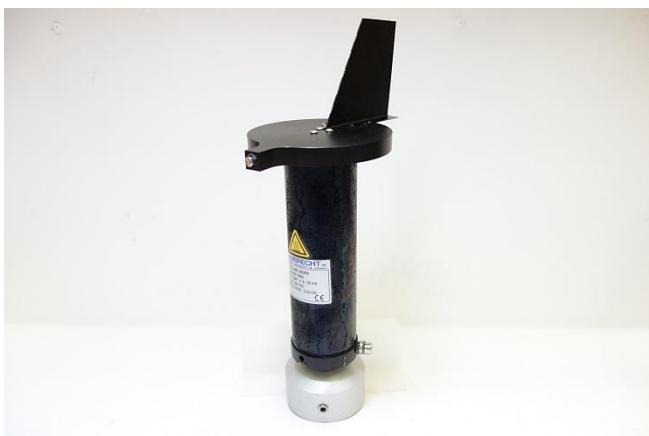
fig. 28

Specimen no. 50-18-0403-5
after the condensation test

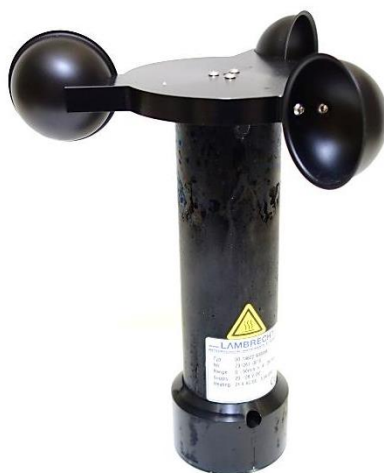
fig. 31

Specimen no. 50-18-0403-6
after the condensation test

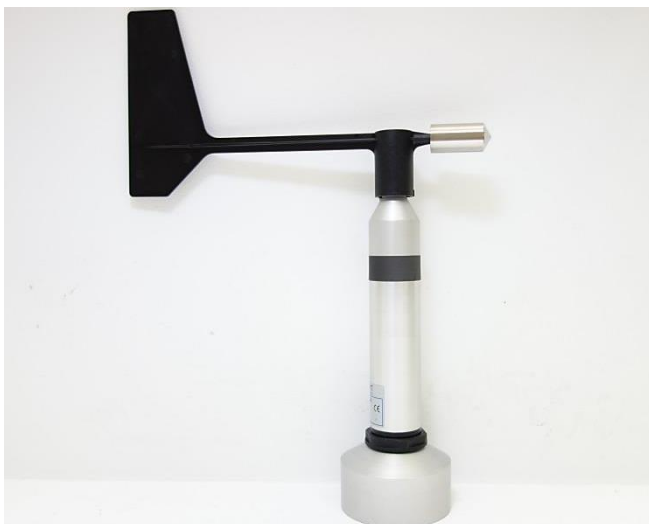
fig. 36

Specimen no. 50-18-0403-7
after the condensation test

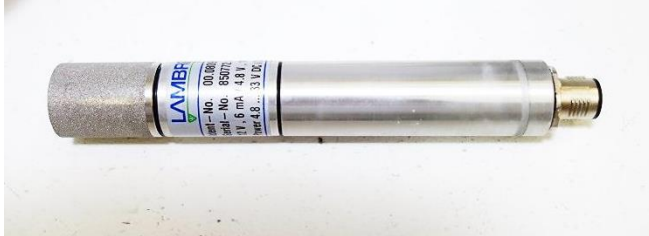
fig. 38

Specimen no. 50-18-0403-8a
after the condensation test

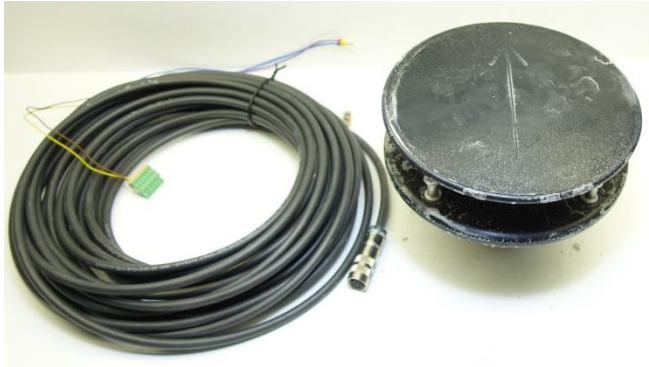
fig. 42

Specimen no. 50-18-0403-1
after the salt mist test

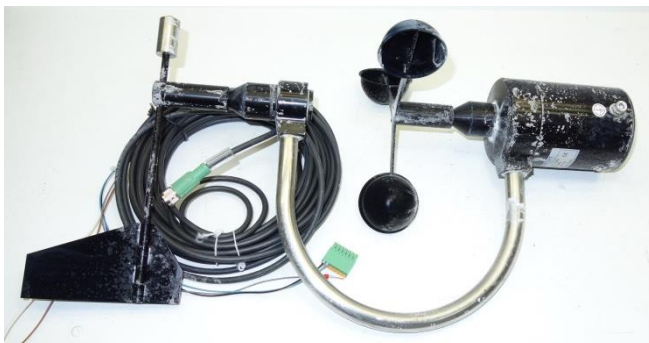
fig. 44

Specimen no. 50-18-0403-2
after the salt mist test

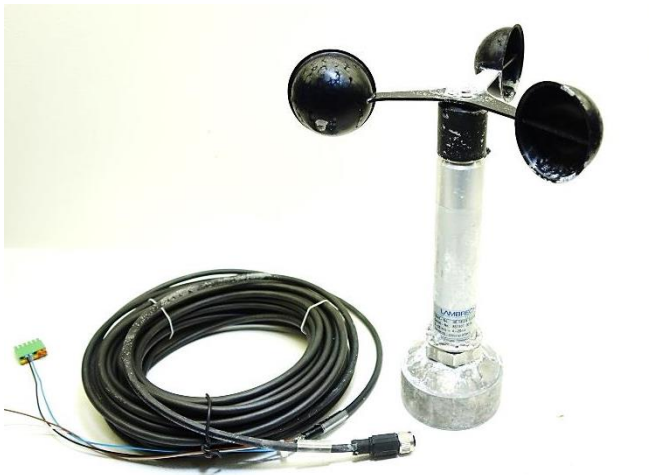
fig. 49

Specimen no. 50-18-0403-3
after the salt mist test

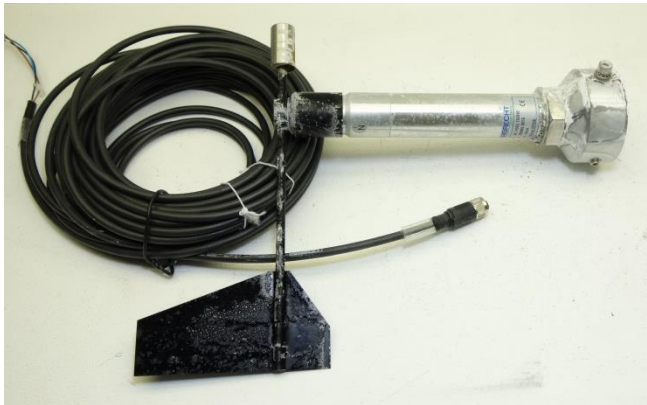
fig. 52

Specimen no. 50-18-0403-4
after the salt mist test

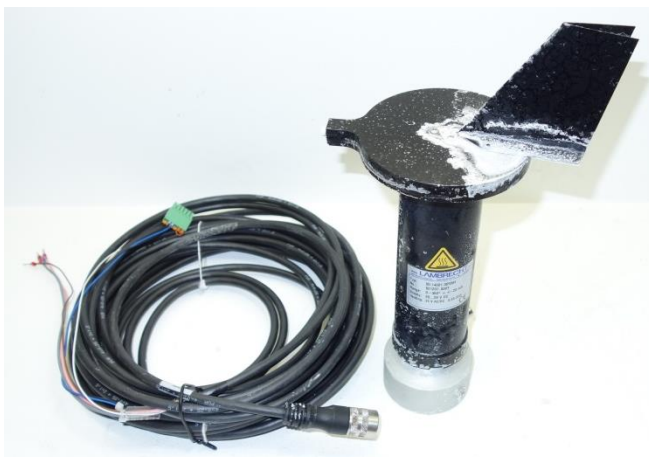
fig. 56

Specimen no. 50-18-0403-5
after the salt mist test

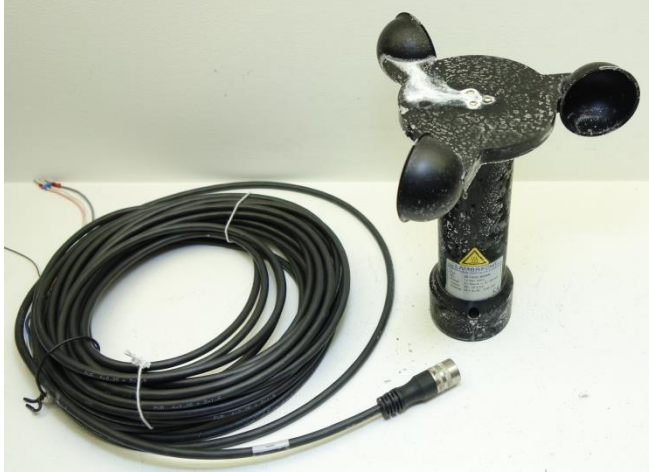
fig. 60

Specimen no. 50-18-0403-6
after the salt mist test

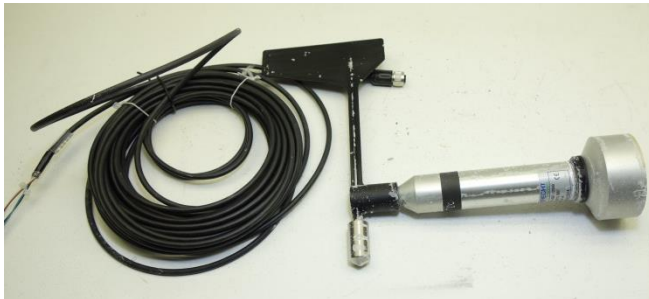
fig. 64

Specimen no. 50-18-0403-7
after the salt mist test

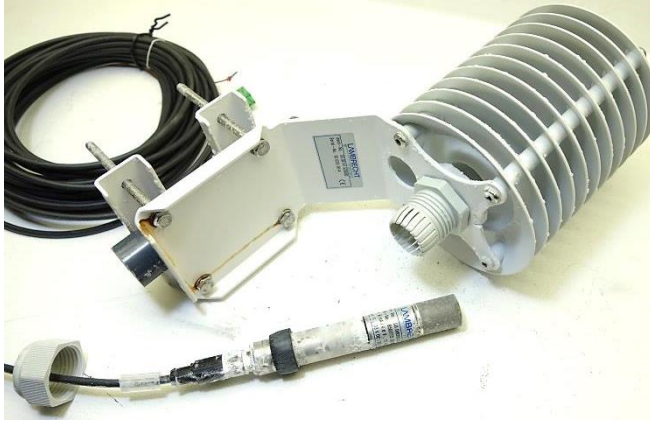
fig. 67

Specimen no. 50-18-0403-8a
after the salt mist test
